SUCCESS LAKE DAM

CT 00079

PHASE I INSPECTION REPORT

NATIONAL DAM INSPECTION PROGRAM

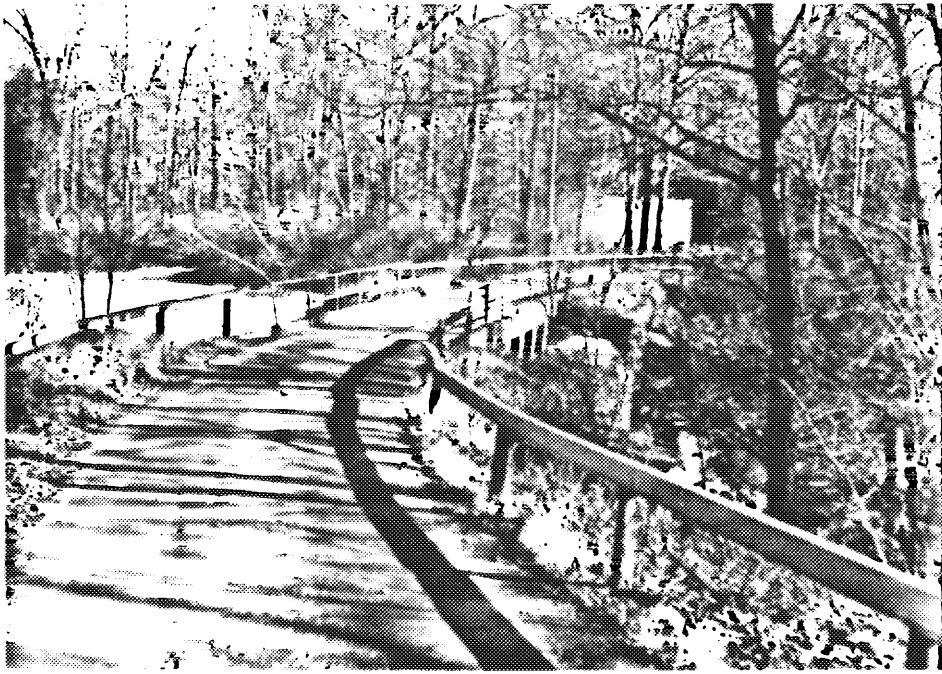
Photo 1 Top of dam and single lane road.

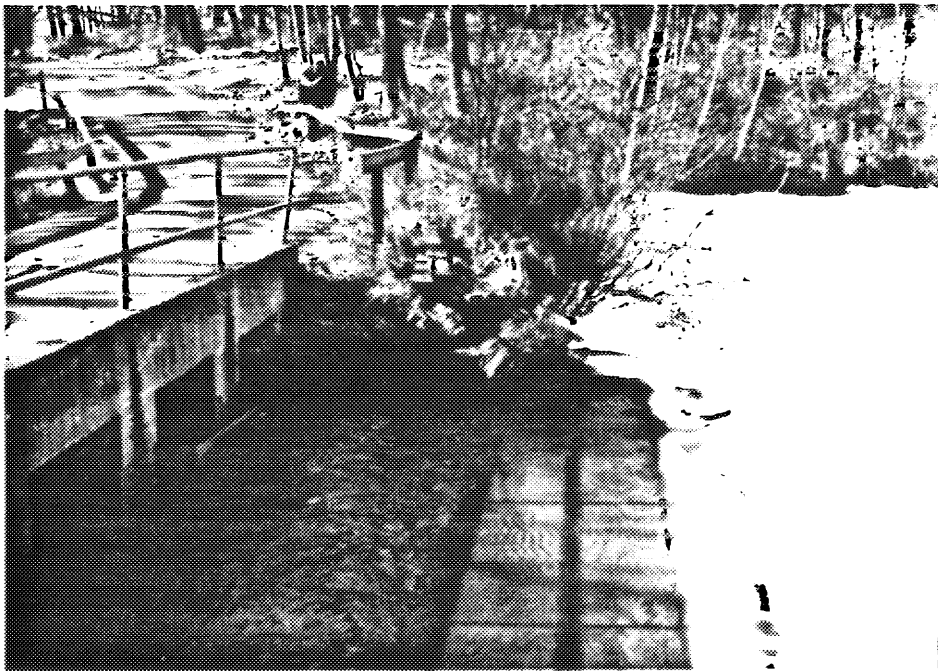
Photo 2 Upstream face of dam, spillway crest and right dam embankment.

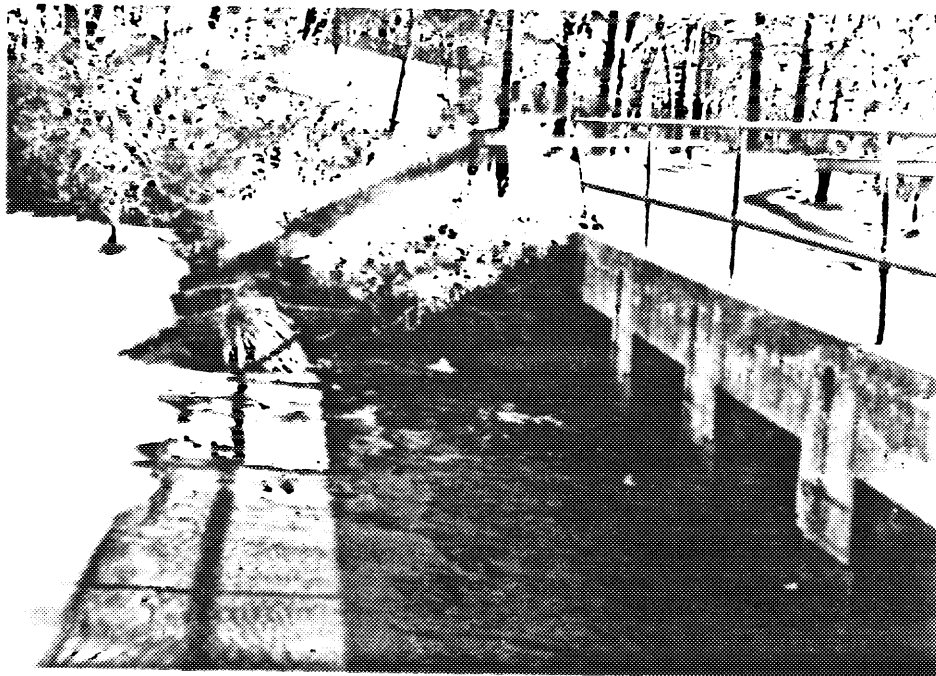
Photo 3 Upstream face of dam, spillway crest and left dam embankment.

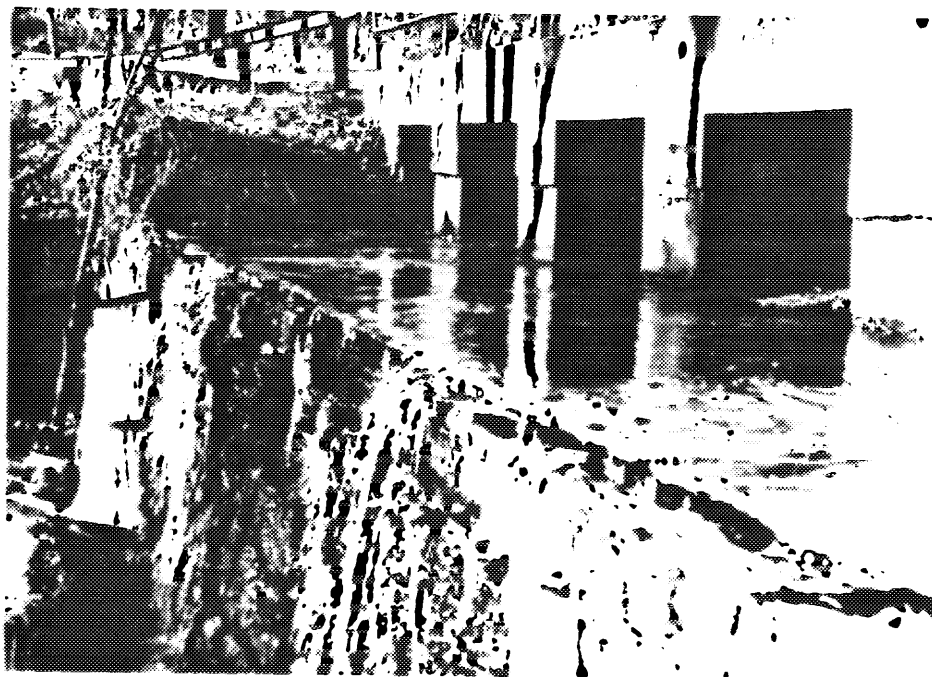
Photo 4 Downstream spillway crest and bridge piers.

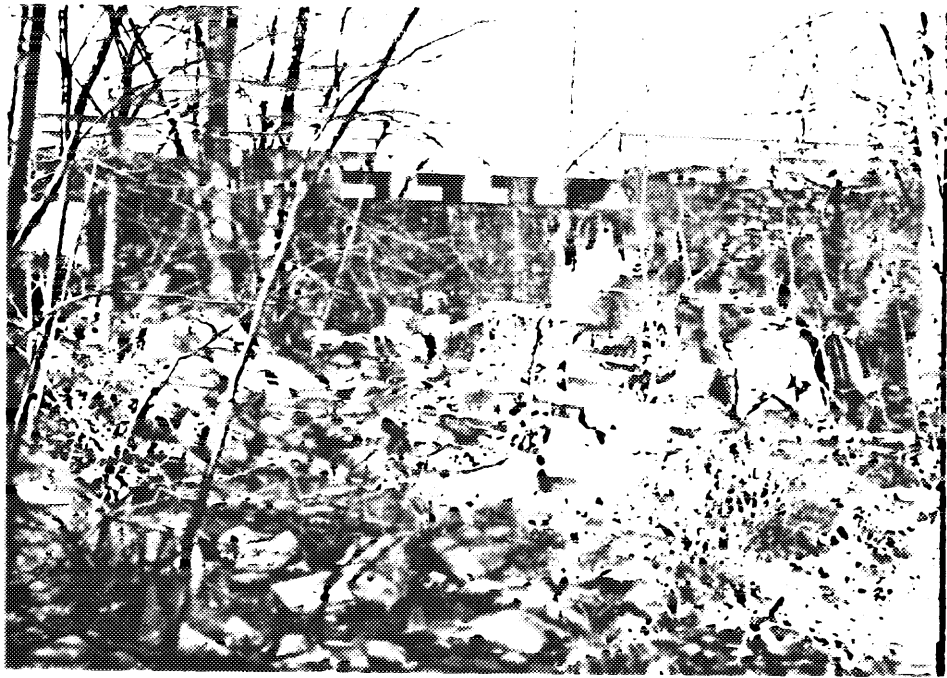
Photo 5 Downstream face of dam.

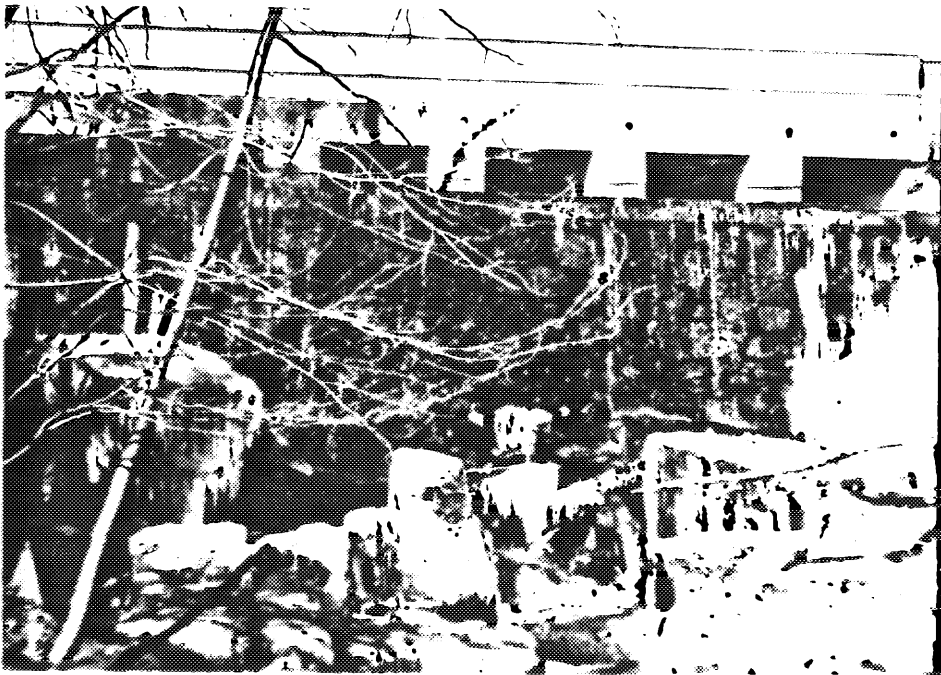
Photo 6 Downstream masonry face of spillway.

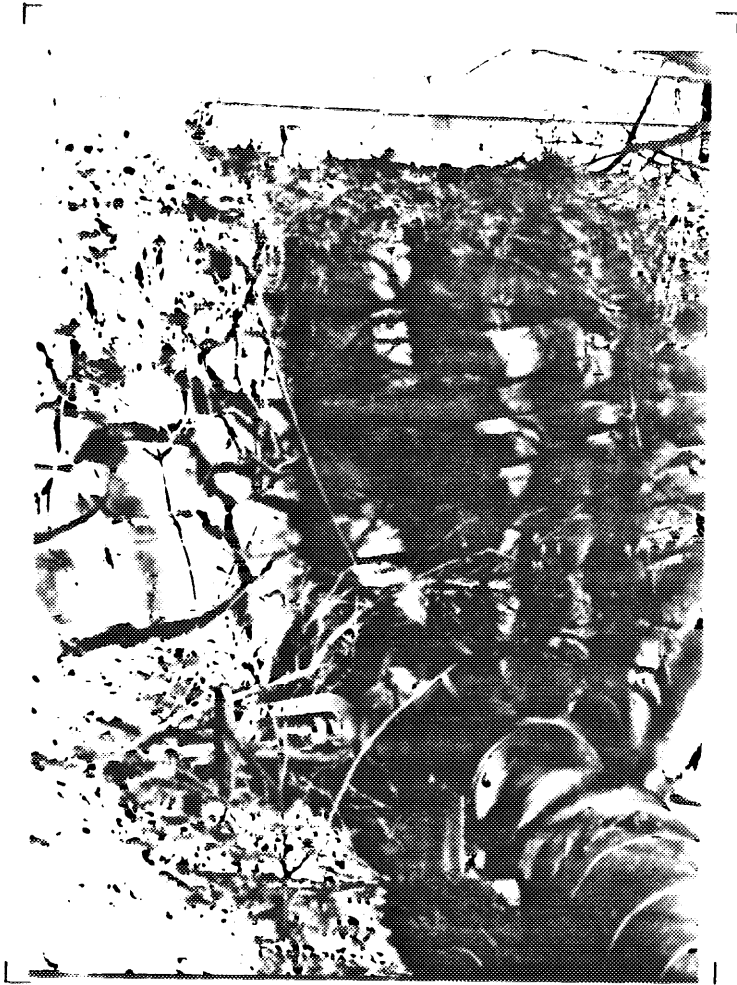
Photo 7 Downstream masonry face  
of right dam embankment,  
8 inch diameter conduit  
and control valve.

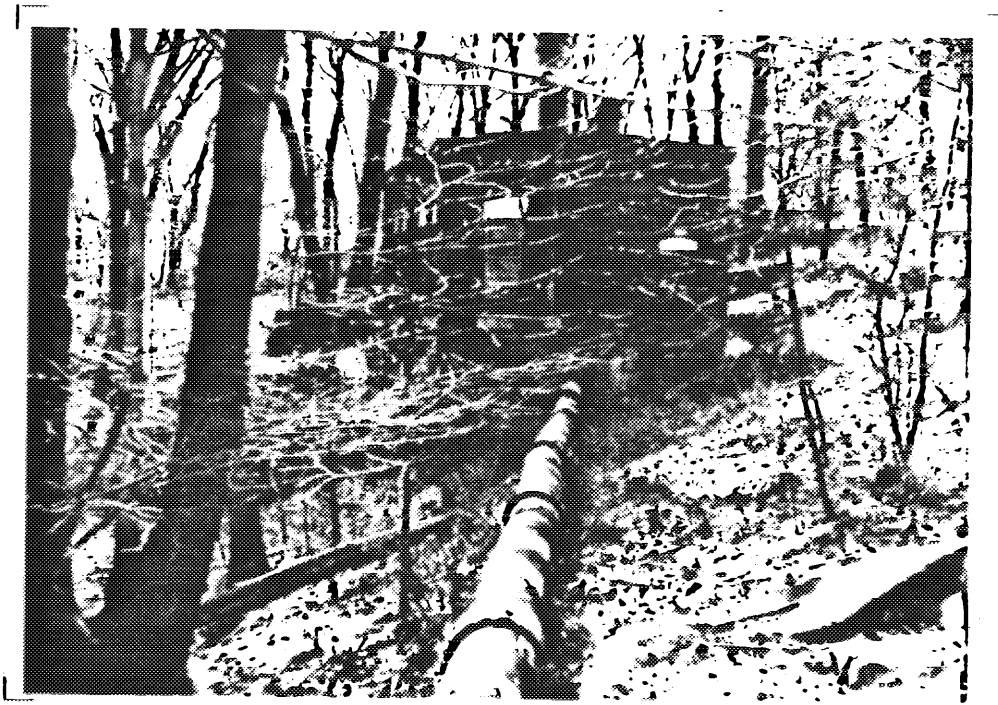
Photo 8 Brick structure and 8 inch diameter conduit.

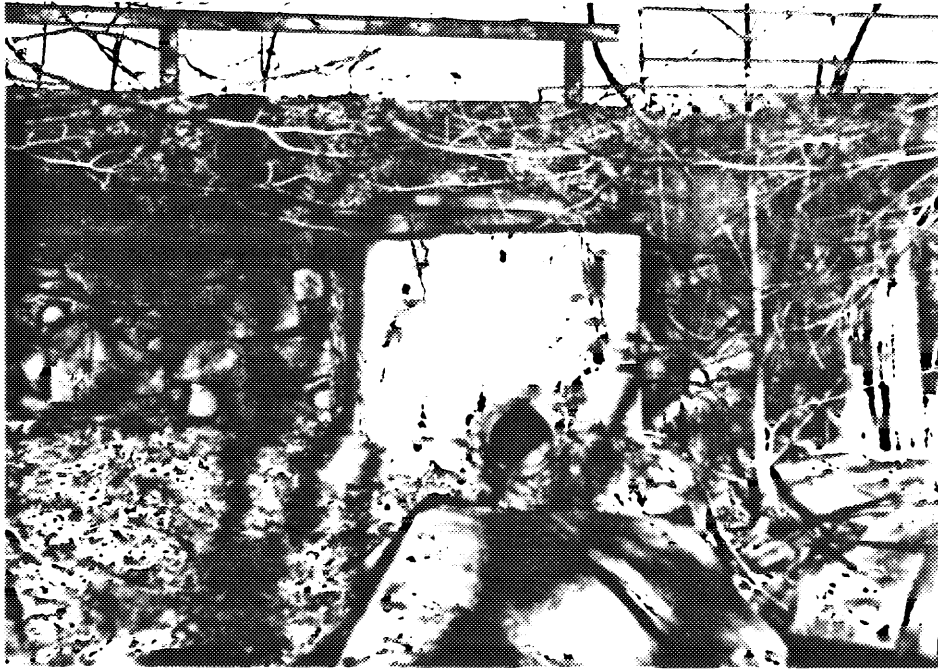
Photo 9 Low-level outlet and valvehouse.
